# NASA TECHNICAL MEMORANDUM

NASA TM X-64820

MSFC SKYLAB COROLLARY EXPERIMENT SYSTEMS  
MISSION EVALUATION

*George C. Marshall Space Flight Center  
Marshall Space Flight Center, Alabama*

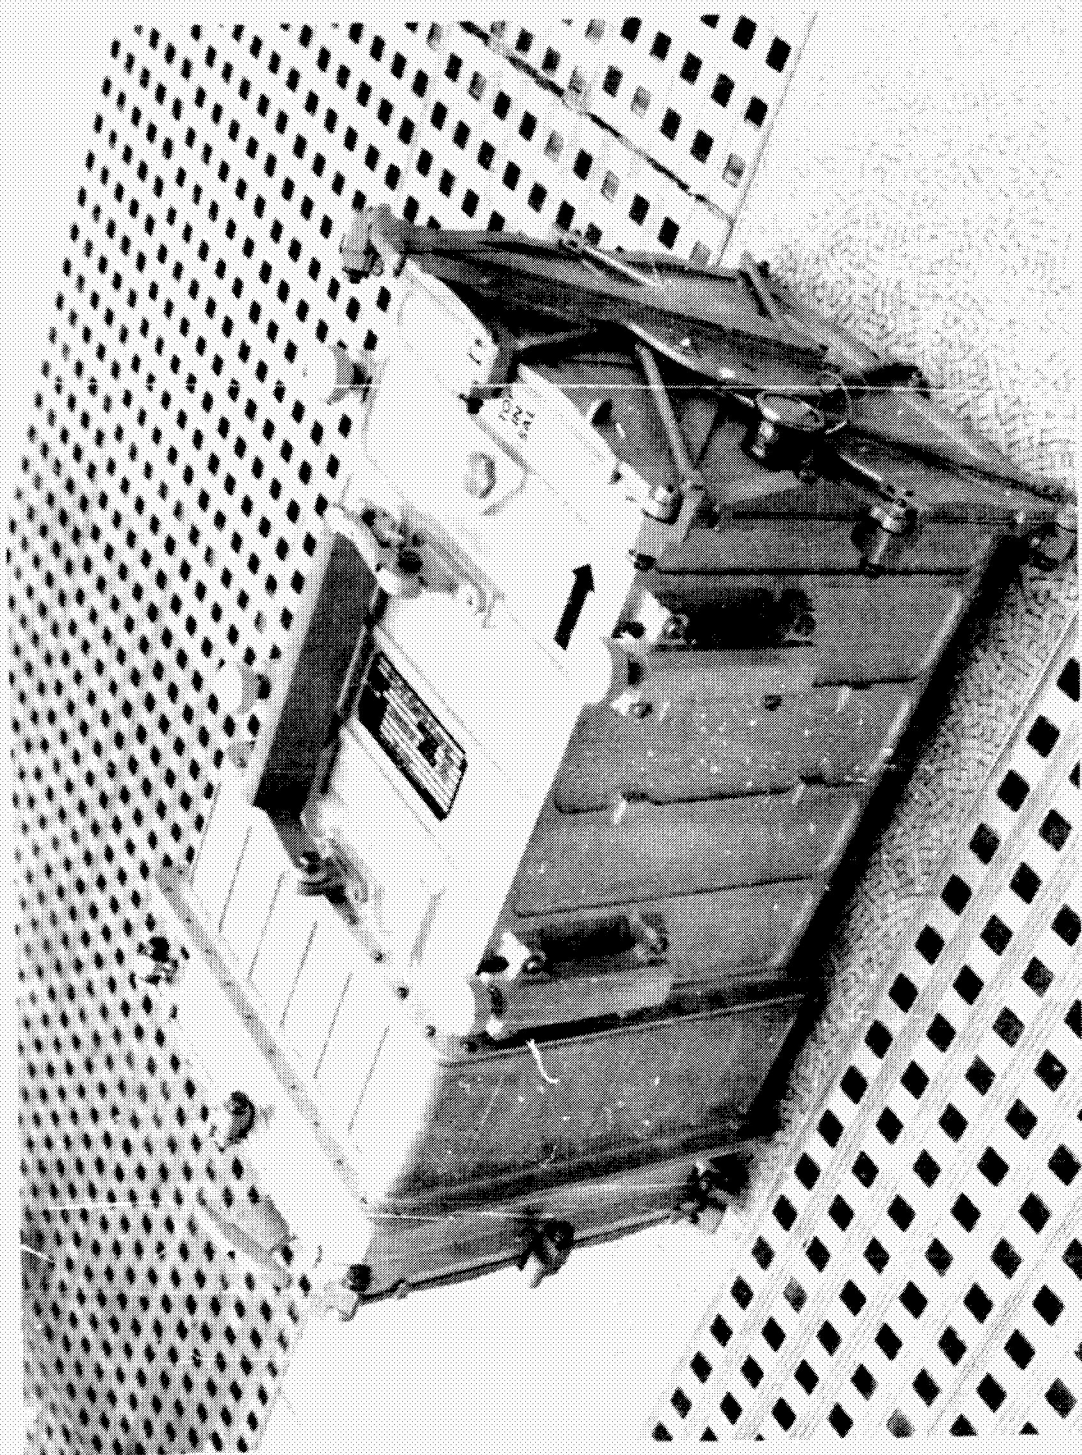
c. Hardware Description. The sample array system (figures IV-23 through IV-26) was designed to expose optical samples to the space environment for controlled periods. The sample array (SA) was deployed outside the spacecraft on a rod; 248 samples of 16 different types were exposed. The samples included window materials, mirrors, gratings, and other optical surfaces designed for various wavelength regions. The assembly consisted of: an upper face plate, an upper box assembly immediately behind the face plate, a waist post, and lower face plate (see figure IV-23). Motordriven, automatically-sequenced carrousels were located beneath the upper and lower face plates. Holes were provided in the face plates to allow sequential exposure of the carousel-mounted optical samples for predetermined time periods. A valve, or cover plate, was provided over the holes in the forward face plate to seal the upper carousel when in the retracted position. The upper (daily) carousel (located beneath the upper face plate) contained 30 samples. Carousel motor sequencing and the face plate hole pattern were designed to allow exposure to the space environment of 25 samples, five at a time, for 24 hours. The remaining five samples, which were control samples, were to be exposed to space for the short period from last carousel indexing to SA retraction, if the SA were exposed for the planned 120 hours. The first upper carousel movement was designed to occur 24 hours after the

FIGURE IV-23. SAMPLE ARRAY EXTENDED

FIGURE IV-24. SAMPLE ARRAY IN EXTENDED POSITION

FIGURE IV-25. SAMPLE ARRAY EXPERIMENT (REAR VIEW)

FIGURE IV-26. SAMPLE ARRAY STORAGE CONFIGURATION
